# Establishing Secret Mining Resulting in Huge Ground Subsidence Due to Conflicting Economic Interests and Repairing Damaged Structures - A Case Study

An interesting study is reported on establishing secret mining activity resulting in severe ground subsidence which occurred and was corrected later in a village called Dhery Saydan located near the world famous salt range region of Pakistan and is located on a hill top with about 2000 inhabitants. After reviewing many cases of similar nature and on basis of geophysical techniques like resistivity survey, it was established that secret mining activity had taken place resulting in massive cracking of dwellings coupled with sinking of water table. Thereafter a suitable construction methodology was applied to correct the huge structural defects and make the dwellings functional.

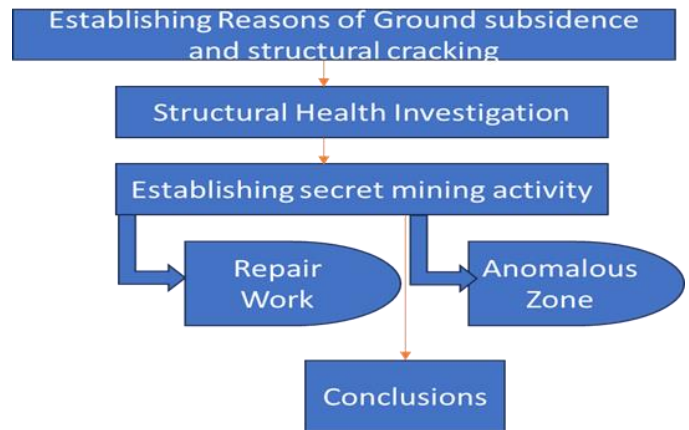
Fig 2: Flow diagram, showing detailed methodology

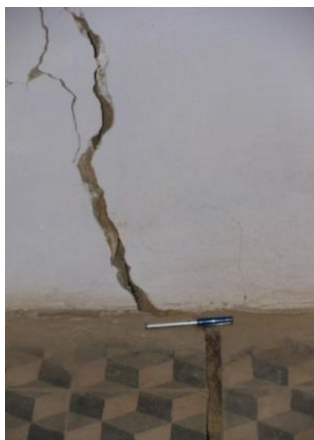
(a) Cracks in solid stone masonry wall

Cracks in dwellings were found in various structural elements like ground floors, walls and roofs. The amount of cracking varied from cracks with small widths to cracks of several inches and sometime feet. The extent of cracking can be considered as heavy and difficult to treat. Skills in area of geotechnical engineering, structural engineering and concrete materials engineering were required and were applied to correct the problems. The possible causes of cracking are ground subsidence include secret mining, total seam extraction, initiation of cracks/fractures in rocks, penetration of water into calcite rock formation having embedded coal seam, earthquake related activity and other possible mechanisms. The causes were looked at from all possible angles and finally some conclusion was arrived at. The purpose of this paper is to briefly review the state of the art of subsidence engineering in Pakistan and to identify potential problem areas and to suggest possible remedial measures.

In first visit, some geological data regarding lithology, bedding and other structural geological data was gathered along with structural inspection of buildings. In the figures below the extent and crack pattern in the dwellings can be seen in figure 3.

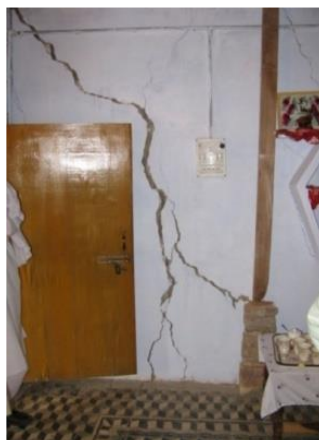
(b) Cracks near the door opening in the stone masonry

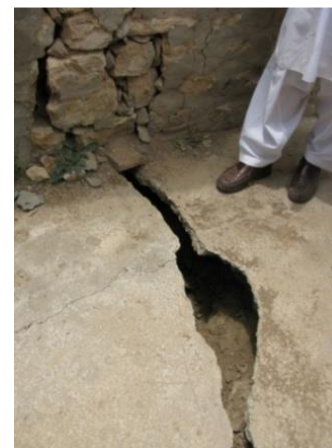
(c) Cracks in floor system

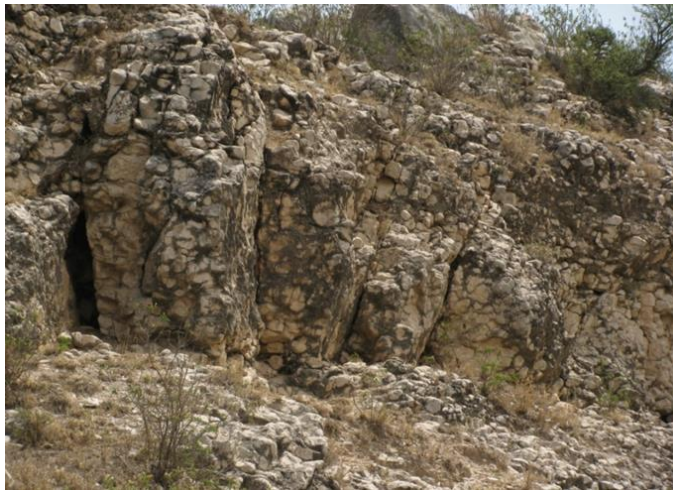
Fig4: Orientation of bedding and joints (Mostly joints are dip joint)

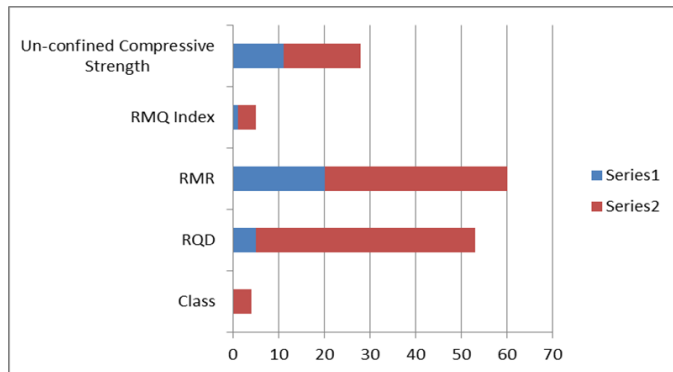
Fig 5: Showing properties of rocks in study area

Sr. No.	Circle No.	Density cm <sup>-1</sup>	Porosity%	Permeability 10 <sup>7</sup> Darcy
1	5	0.144	13.2	6.9
2	6	0.16	12.6	7.5
3	8	0.08	10.4	10.1
4	4	0.104	9.9	6.08
5	15	0.109	7.2	4.4
6	9	0.07	7	6.7
7	10	0.063	6.4	3.5

Table 1: Fracture Density, Porosity and Permeability of Sakesar Limestone (Coal seam Overlying rock unit)

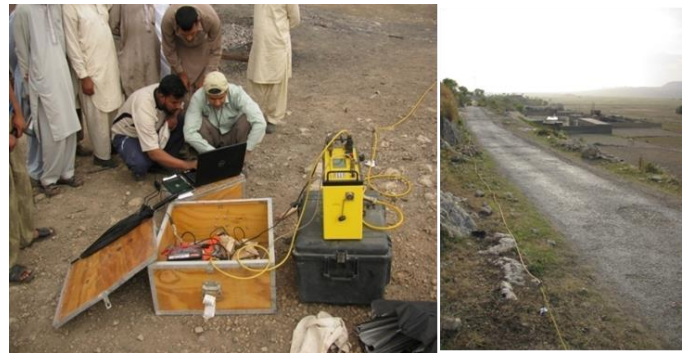
Fig 6: Electrical Resistivity test in progress at Dhery Syedan with AGI Sting Equipment.

Electrical Resistivity test was conducted by using AGI Sting R1 IP instrument. Electrodes were laid at an interval of 6m to cover a wide area. The test was performed in sunny weather. The area of study was a small half ridge mountain with surface outcrop of Sakesar Limestone. Resistivity measurements were taken in the area to detect the cavities in order to alert city authorities. Resistivity data along most of the streets were collected with the array Dipole-dipole that consisted of 28 grounded electrodes. We performed 2-D inversions to the data in order to get a 2-D resistivity image of ground under study.

It was decided to conduct electrical resistivity tests which resulted in graphs capable of showing anomalous regions, their location and size. The test was run by giving the impression of carrying out a survey for the supplying telephone and water lines. Had the people of area known that it was being carried out for establishing secret mining, it would have been impossible to carry out this test due to armed villagers having conflicting economic interests. Though the support of Police was also requested, it was found that it had also been financially influenced. Towards the end of tests, some of the villagers got suspicious and the work had to be completed hurriedly using the help of group of villagers in favor of unearthing the crime. Figure 4 shows the electrical resistivity test in progress.

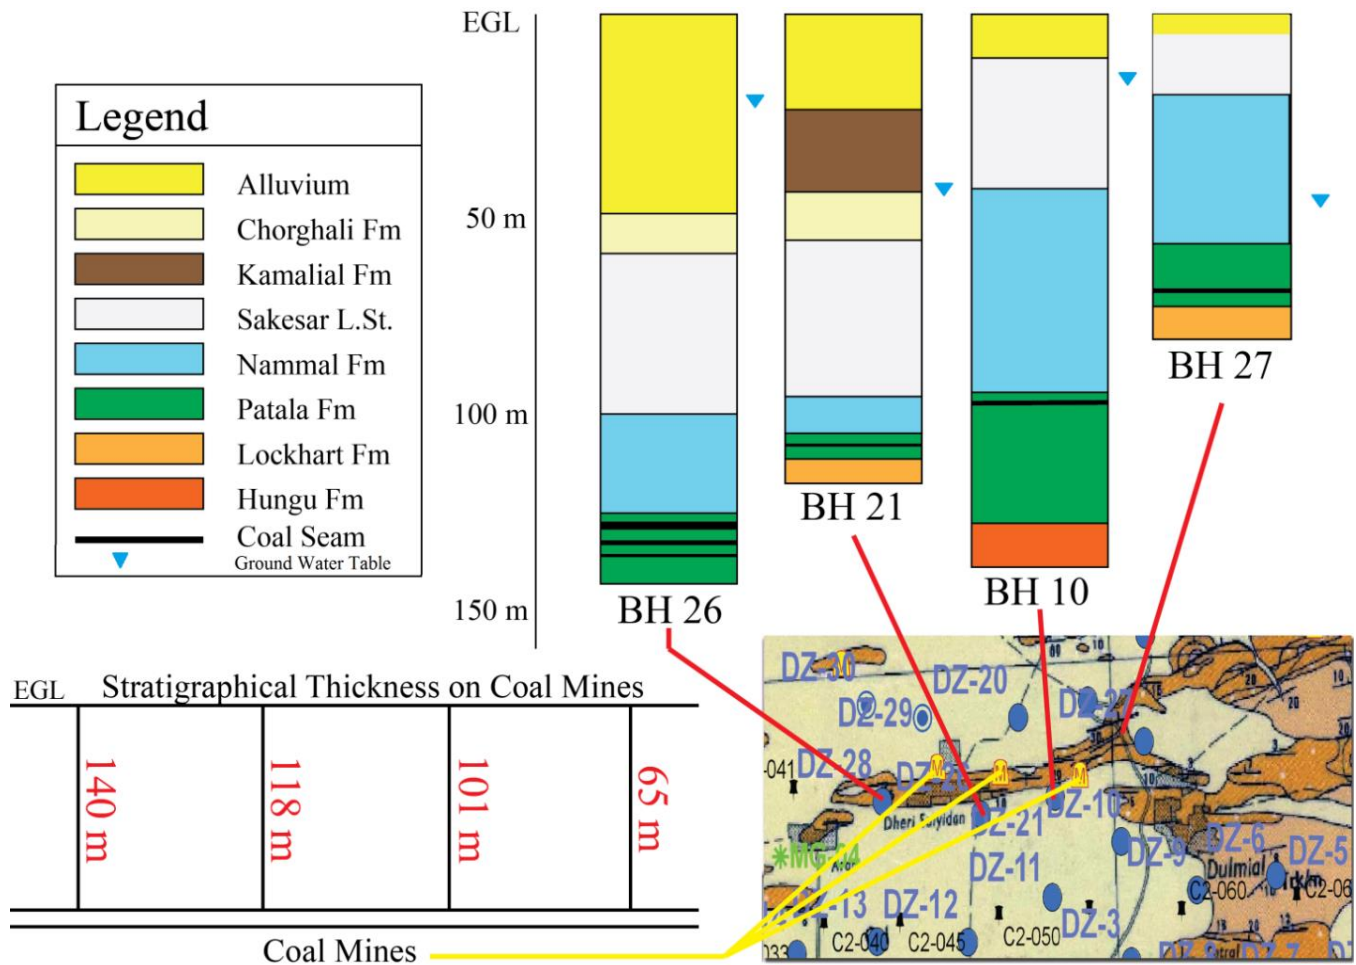
Fig 7: Result of drilling and overburden thickness over mines in study area.

The overburden thickness plays a very important role in subsidence. Generally, subsidence decreases with increasing overburden thickness. Shallow mining faces more subsidence relative to mine having more overburden thickness with less discontinuities [19]. After establishing secret mining and reasons of structural damages, the following results have been drawn and discussed as follows

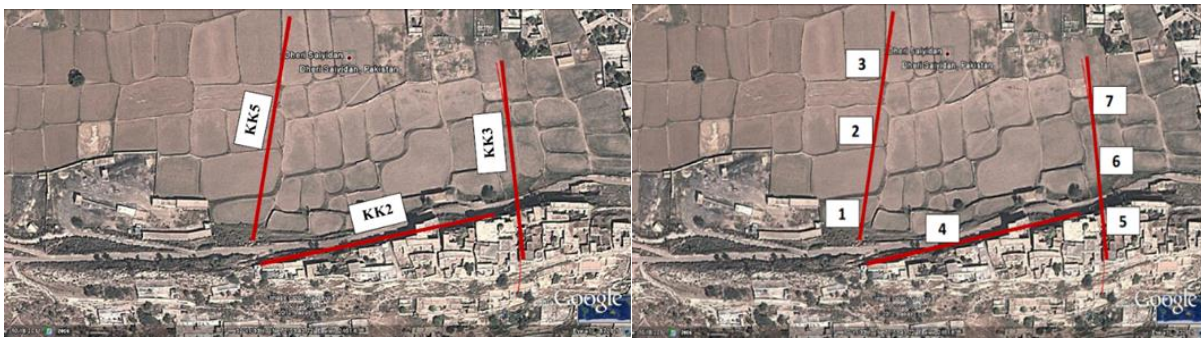
(a) Locations for Electrical Resistivity Test (b) Possible Location of Anomalous zones

Fig 8: Locations for Electrical resistivity Tests and Anomalous zones.

Anomalous zones identified in resistivity profiles (Figs. 15, 16, and 17) may possibly be cavities or tunnels made by mining activities. Location of these anomalous zones is marked on Fig 18, and their coordinates are given in Table 2. These cavities were confirmed by further confirmatory/exploratory drilling at suspicious locations, as shown in Figure 7. Moreover, geophysical exploration techniques like resistivity survey,

Serial No.	Northing	Easting	Serial No.	Northing	Easting
01	32°44'31.97N	72°53'42.05E	05	32°44'32.41N	72°53'49.23E
02	32°44'32.86N	72°53'42.69E	06	32°44'34.30N	72°53'49.32E
03	32°44'35.12N	72°53'43.02E	07	32°44'34.90N	72°53'49.16E
04	32°44'32.12N	72°53'45.90E

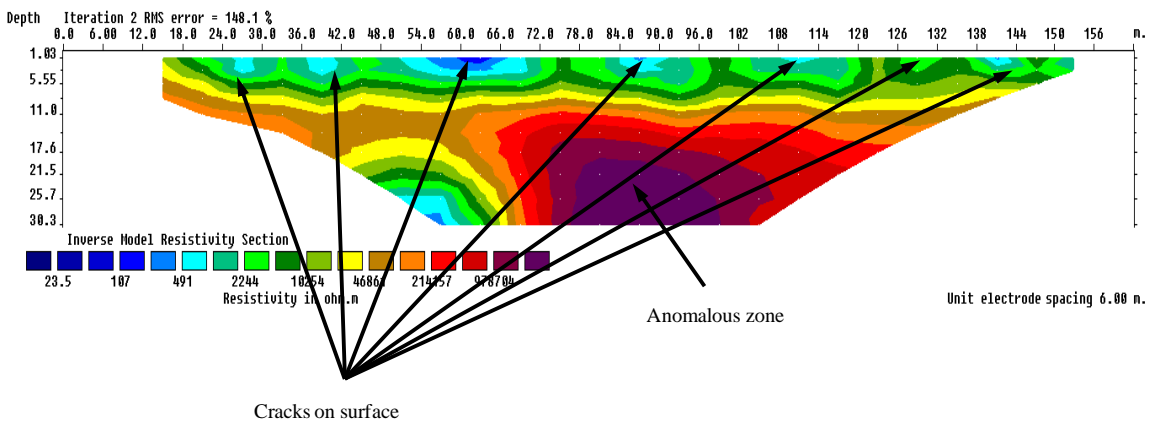
Sting/Swift prg: KK3

(b) Electrical resistivity profile along line KK3

Fig 9: Profiles from Resistivity test with possible Anomalous Zones.

The presence of anomalous zones was confirmed due the maps print out of electrical resistivity tests showing the existence of anomalous zones and thus establishing secret mining activity. After having confirmed secret mining activity coupled with water seepage resulting, the slippage of boulders due to draining out of sandwiched clay, the repair work was carried out.

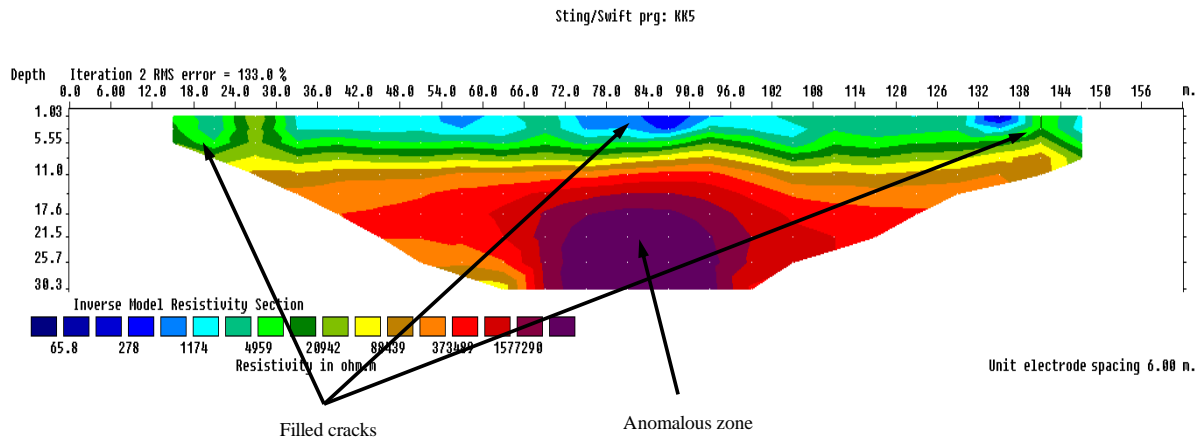
(c) Electrical resistivity profile along line KK5
